4 Crankshafts

Villiers Singles Improvements Handbook 3

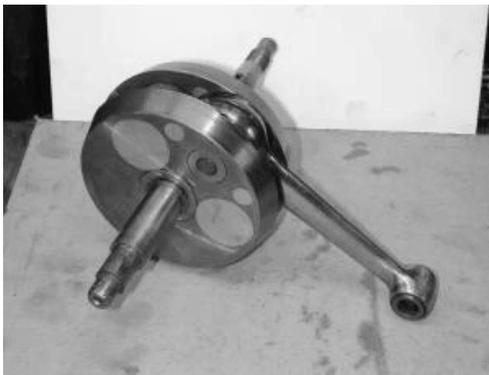
Figure 14 Alpha crank Mk1

two stroke motors. To counter this problem Alpha came up with a superior replacement shaft which fitted straight into the Villiers cases, this item being used quite extensively by many works teams, solving their twisting problems.

The Alpha crankshaft had full circle flywheels with reduced crankcase wall clearance which not only added rigidity but also increased the primary

compression ratio, which aided cylinder filling. Designed as a flywheel effect shaft the Alpha crank did not need the Villiers heavy external flywheel, but in the trials application with the flywheel and the extra weight of the additional ring, the better cylinder filling increased plonkability markedly.

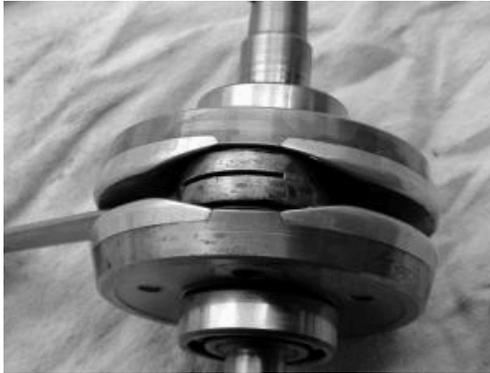
Figure 15 Alpha crank Mk2

With the Alpha shaft came a streamlined conrod (of both lengths) and a superior racing type bigend bearing, but the small end remained bushed as in the Villiers rod. The very early rods had a big end width of 0.5",

and a single diameter pin, which ran in parallel flywheels. This was later to be increased to 16 mm, the flywheels being machined away around the pin to accommodate the stepped pin, larger bearing and thrust washers. Much of the increased rigidity came from the larger crank pin of the early type and the later stepped crank pin which was needed for the larger big end bearing which now measured 25 x 32 x 16 mm. The outer diameters of the stepped crank pin are not the same size as the Villiers pin, therefore rods and cranks are non interchangeable without recourse to machining, so measure up the fit if mixing Alpha shaft rods with the Villiers webs.
